Manhole Inspection Summary

Manhole # S09MM1022MH

Location Address: **4900 DENMORE AVE**

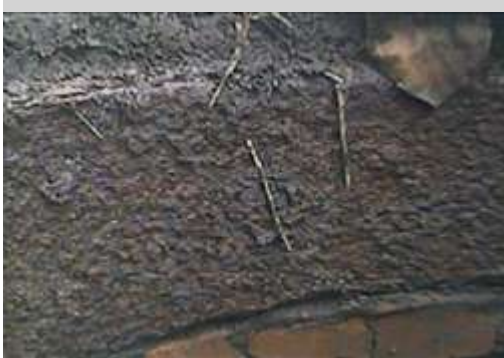
Defect 3

Condition: ☐ Sound ☐ Cracked ☒ **Leaks**

INFLOW AROUND FRAME

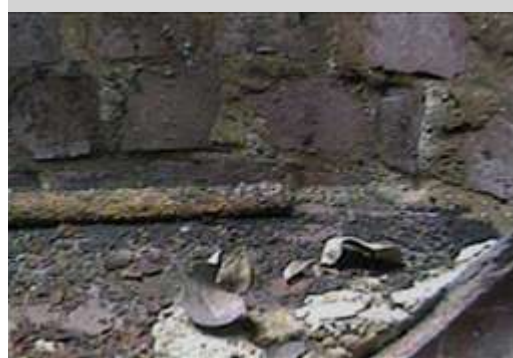
Defect 2

DEBRIS ON BENCH

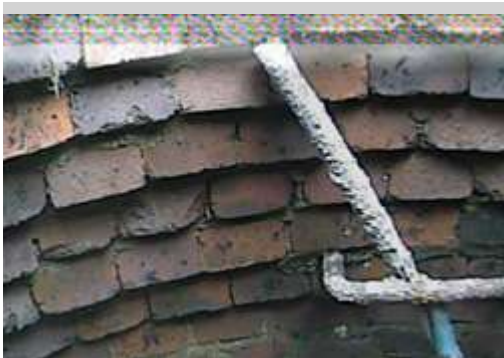
Defect 1

Condition: ☐ Sound ☒ **Cracked** ☐ Root Intrusion ☐ Loose Brick ☐ Deteriorated

CRACKED CORBEL

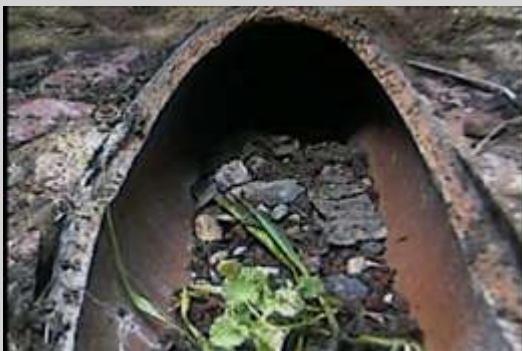
3 O'Clock Inflow

Pipe Height: **2.4** (in.) Rod and Bar
Pipe Material: **Clay** ☐ Pipe Lined
Invert Depth: **3.35** (ft.) Flow Characteristics: **None**
Deposits: ☐ None ☐ Mud ☐ Sludge ☒ **Debris** ☐ Grease
Silt Depth: **3** (in.) Deposits Extent: **Medium**
Infiltration: **None** Pipe Seal Cond: **Cracked**

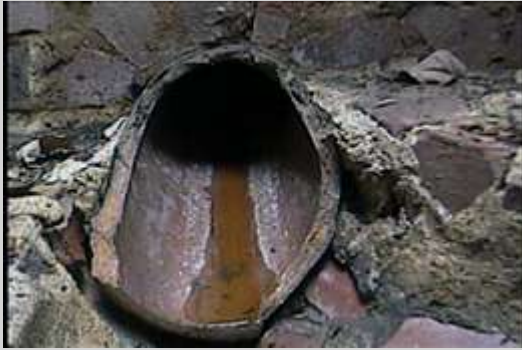
9 O'Clock Inflow

CRACKED CHANNEL
